## Life of Bus Garages Extended By Re-Roofing with Metal

BUILDING: SCHOOL BUS BARNS

LOCATION: RAYTOWN, MO.

OWNER: RAYTOWN SCHOOL DISTRICT

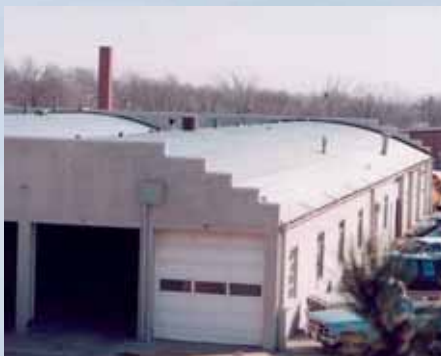
Decades of exposure to the Midwest climate left areas of the curved roofs above the two garages with holes large enough to admit daylight. The steady pounding of rain and snow also rotted the roofs' wood valley gutters. In winter, the leaky roofs produced dangerous ice patches along the parking spaces putting bus drivers at risk as they walked to or

concrete block walls. Three 35-foot-long trusses and three 50-foot-long arched trusses were aligned side by side across each building, creating two flat valley gutters at the junctures above each load-bearing wall line. Corrugated sheeting was then fastened to 2-inch by 10-inch by 12-inch wood purlins that served as the roof's secondary support.

Before Retrofit

Based on RTI's recommendations, the district replaced 28,700 and 21,230 square feet of curved roofs with two low-slopped, standing-seam systems made of Galvalume-coated steel. School district officials contend the new metal roof has eliminated the problematic roof "valleys," yet requires virtually no maintenance.

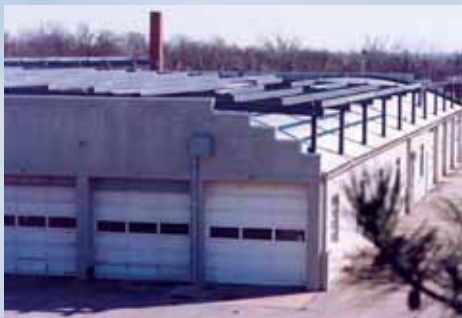
The new roofs were installed over the existing roofs after “piggyback frames” were welded to the original, underlying trusses. Metal wall panels were used to enclose the exposed vertical gap between the new and old roofs.

The “piggyback framing” consists of H-section beams and columns tall enough to create the desired slope in the new roof plane. The beams and

During Retrofit

columns were attached to the trusses with custom brackets that were welded to the top chords of trusses at the valleys and crowns. Loads transfer from the new standing seam roof systems through the new piggyback framing to the trusses and then into the concrete block walls. A series of 9-inch Z-purlins spanning the distance between the piggyback frames received the new metal roof.

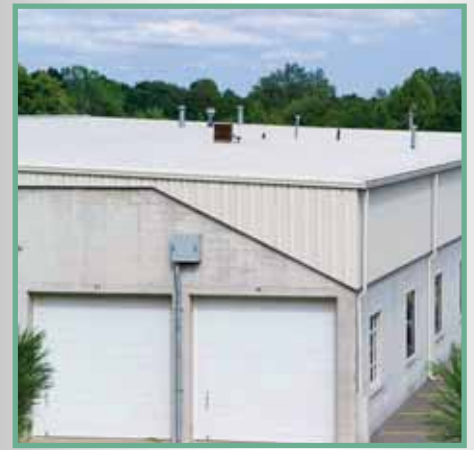
## SPECIFICATIONS

PANEL TYPE: *STANDING-SEAM COATED STEEL*

SIZE: *24" X 2 3/4", 24-GAUGE*

PROFILE: *TRAPEZOIDAL RIB*

COLOR: *STANDARD GALVALUME FINISH*
